GILFORD·JOHNSON
FLOORING

Gaps Appear in This Wood Floor Despite Humidification ...Why?

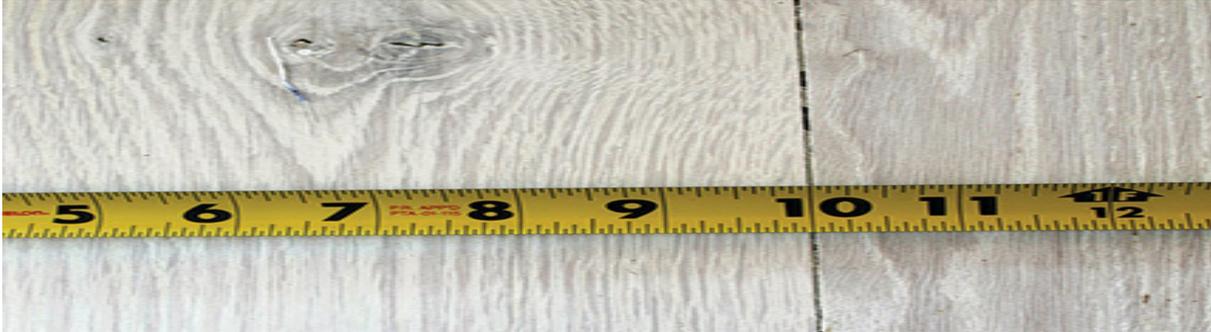
The newly installed plank floor was gapping and cupping.

The gaps were affecting the entire installation but were in greatest quantity in the great room, where they ranged from 0.002–1/16 inch. There were random gaps that measured 1/8 inch. I observed cupping, which measured from 0.006–0.040 inch, in approximately 30 percent of the floor.

I determined that since installation, the wood flooring had lost moisture, causing the gaps, and that the cupping was consistent with the moisture imbalance in the installed flooring. According to Aprilaire, the humidification system installed in the home would not accommodate a home of this size, which was 6,000 square feet.

A correctly sized steam humidifier was installed. When I returned at the end of February, it had been running for one month, and the RH was 55% at 71 degrees. Approximately 90 percent of the gaps had closed, and the cupping was gone.
