## Wood Flooring Shearing or Delamination? And Who's at Fault?

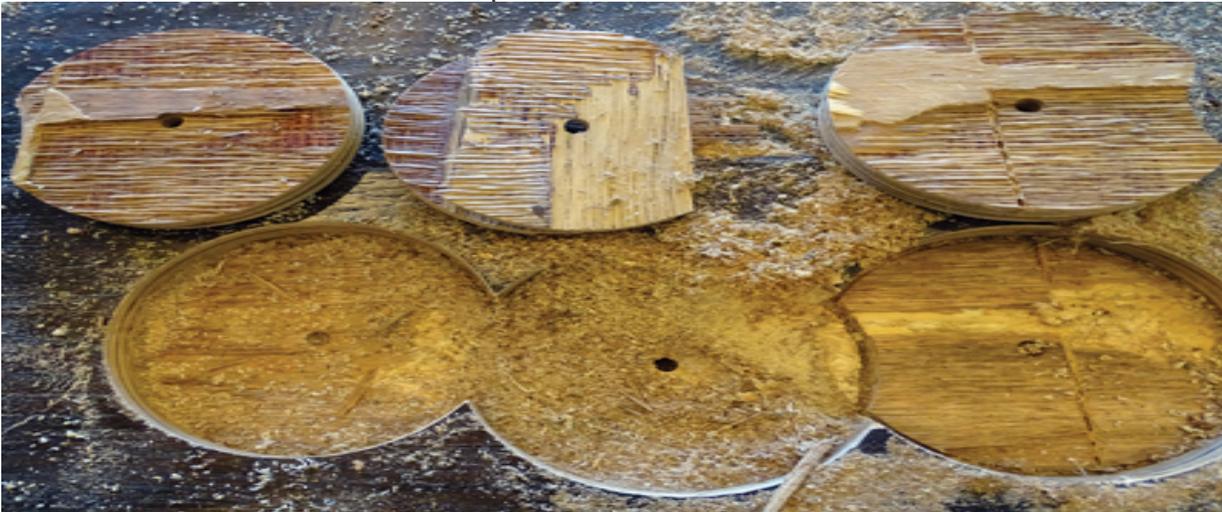
Wood fibers can clearly be seen attached to the adjoining layers of these pucks cut with a hole saw. The failure was caused by wood shear, not delamination.

I was given permission to complete destructive testing with a hole saw to investigate the integrity of the bond-line joints at various depths of the engineered flooring. There was wood fiber still attached to the bond lines, so I determined the problem was not bond-line failure but wood shear. This issue is most likely related to the environment rather than a manufacturing defect. I asked about the HVAC and learned the homeowners' HVAC does not have a humidifier and was therefore installed in the attic. The flooring manufacturer states in its guidelines that 35–55% relative humidity must be maintained at all times. The homeowner said they were never informed they needed a humidifier, and the builder said the flooring retailer did not tell him humidity control was required. Everyone involved with the job thought an engineered floor didn't need climate control because they believed engineered flooring was supposed to be stable enough without it.
